FEAP-TR-FE-93/11
November 1992

**TECHNICAL
REPORT**

Demonstration of Tankless Water Heaters in Army Family Housing

by
Lee A. Edgar

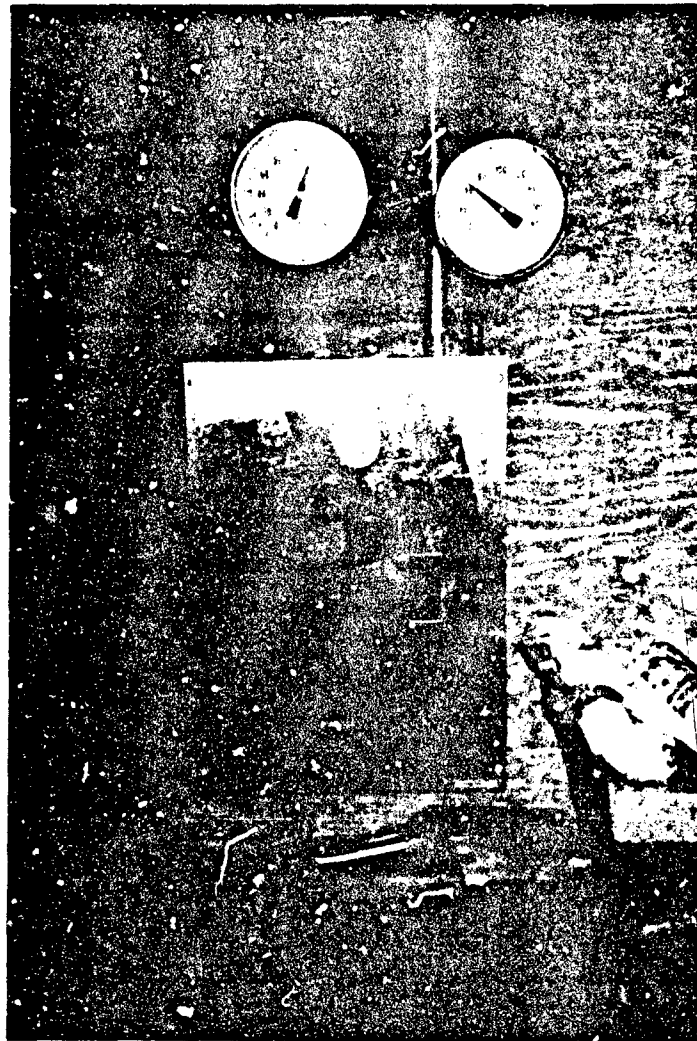
Figure 1. The Hot Box Tankless Electric Water Heater.

The tankless electric water heater used in this demonstration was the Hot Box, manufactured by HurriSystems, Inc. (see Figure 1). The Hot Box uses electric resistance elements to instantaneously heat water to a specified delivery temperature. A flow switch in the Hot Box turns on the heating elements when there is demand for hot water. When the user turns on the water, the Hot Box detects the flow and energizes the element to heat the water passing through the unit. The unit's heating elements are arranged in stages so the unit can change the water temperature as the flow rate changes.

Tankless water heaters are rated on the basis of the temperature rise the unit is capable of producing. If a tankless water heater is capable of producing a 60 °F rise at 2 gallons per minute (gpm) and the inlet temperature is 55 °F, then the outlet temperature would be 115 °F.

At rates below the specified flow rate, the unit provides a larger temperature rise, while at higher flow rates, the unit provides a smaller temperature rise. Because the Hot Box is designed to provide a temperature rise of 60 degrees at 2 gpm, it can produce 120 gallons of hot water per hour (2 gpm x 60 minutes/hour). At the same time, the Hot Box is very compact, measuring only 19.5 in. x 14 in. x 4.5 in., and is designed to be wall mounted. The Hot Box cost \$250 at the time of the demonstration.

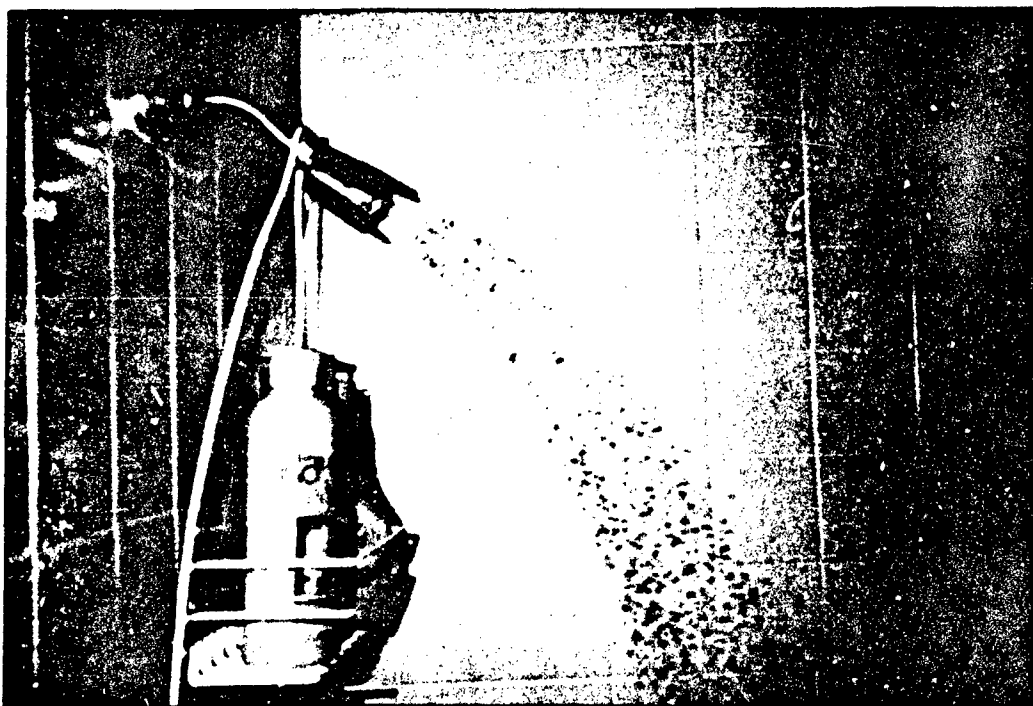
The residents at 2072N also reported insufficient hot water early in the demonstration. The residence had hot water, but the flow rate in the upstairs shower was much lower than it had been under the old system. Figure 11 shows the original flow of the shower and Figure 12 shows how the Hot Box reduced the flow. This reduction of flow was apparently due to the smaller diameter pipe used inside the Hot Box to reduce the maximum flow rate to about 2.5 gpm. To address the resident's complaint about the low flow rate, the hot water service was switched back to the original system.

Figure 12. Reduced Flow in Upstairs Shower Due to Hot Box, Residence 2072N.
